The Mary Rose - Deck Construction

Stuart Vine

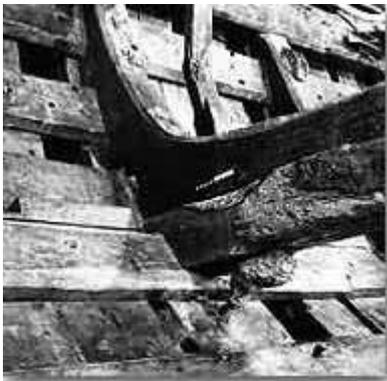
Orlop deck clamp

The deck beams are housed in rebates cut into the upper/forward faces of the deck clamps and sit slightly proud of their rebates. The inboard faces of the deck clamps have been finished with an adze and are chamfered on their lower edges.

This serves both to house the outboard ends of the deck beams and as a stringer, treenailed through the frames and hull planking to provide longitudinal strengthening to the hull. The orlop deck clamp consists of five sections of timber, scarfed together vertically, running from O1 to O12.

Unlike the main deck clamp, the orlop deck one is not deliberately cut thicker beneath the deck beams. While there are slight variations in thickness, this appears to be an accidental rather than a deliberate variation.

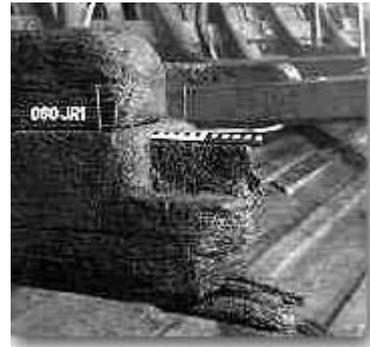
O60 carling rebate

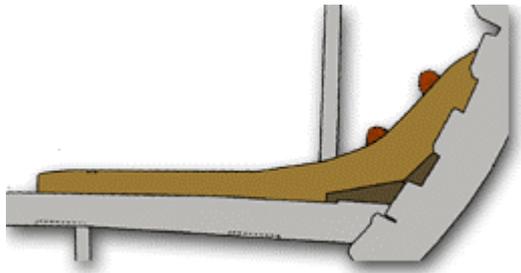
030 rising knee, the inserts are the dark brown areas, while two concreted bolt heads protrude from the upper face.

All the knees are cut from a single piece of grown timber and are rebated to fit around the starboard side stringers. ORK 30 has two inserts adjacent to the starboard side, compensating for the shape of the timber. The inboard faces of the knees are cut in a smooth curve and are not stepped like the main deck rising knees. This means that the whole length of the knee protrudes above the deck planking, dividing the orlop deck into discreet sections.

The orlop deck beams are supported by rising knees bolted to their upper faces. In turn the knees are bolted and treenailed to the hull. There are two to four bolts fastening the knees to their beams, and two to three bolts attaching the knees to the hull. Four of the knees, ORKs 30, 50, 70 and 80 have a shallow, transverse lap joint on the underside, matching one on the deck beam below.

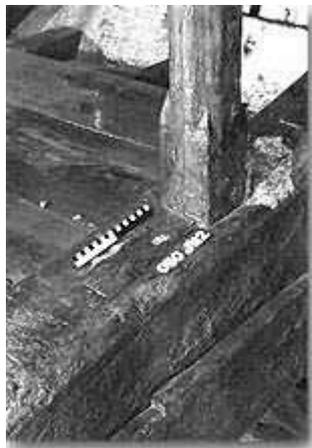
The upper faces of the knees have square and sliding mortices to house the tenons of the orlop stanchions.

Stanchion and sliding mortice. The mortice is filled with a small wedge, nailed in place.

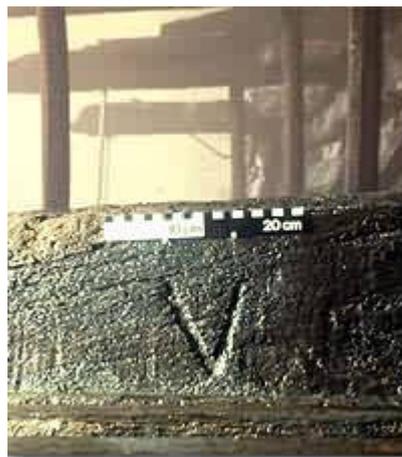
Mark on O50

A unique feature of the orlop knees is the incision of large roman numerals in the aft faces of ORK20, ORK40, ORK50, ORK70, ORK80 and possibly on ORK100, although this looks more like accidental damage as opposed to deliberate marking.

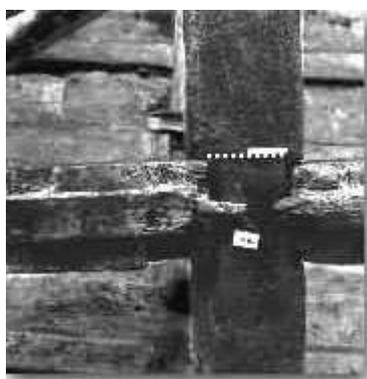
The O10 to O40 carling was made from a single piece of oak, 9,000mm long, 280mm wide and 180mm thick. While the other carlings have similar widths and thickness' it is difficult to establish how many individual timbers comprise the carlings between O50 and O110, owing to the damage they have sustained where they pass over the deck beams.

Damaged carling at O80

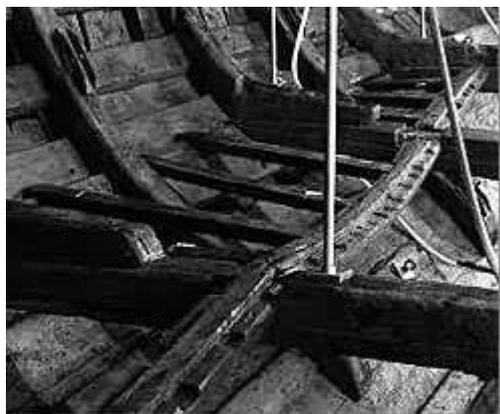
Angled rebates have been cut into both the inboard and outboard faces of all the carlings except O5. The rebates on the outboard face house the orlop deck half beams, and those to inboard the hatch cover half beams. It is doubtful that the inboard rebates on the O6 carling were actually used, the presence of the pump and main mast rising through that section of deck would seem to prevent the use of hatches in this sector, and indeed none were found in H6/O6.

Hatch cover half beam rebates

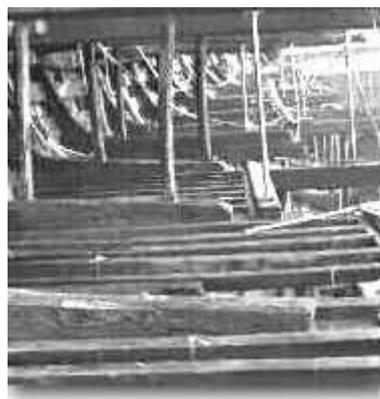
The starboard ends of the half beams rest in rebates in half beam shelves and are angled in both the horizontal and vertical planes to fit against the side of the ship or into rebates in the braces, while the port ends angle gently to fit into the rebates on the carlings. As with all the half beams in the ship the angle extends beyond the carling rebate, creating a weak spot. The surviving tool marks show that they were sawn timbers, with some being partially dressed with an adze.

View along the orlop half beams

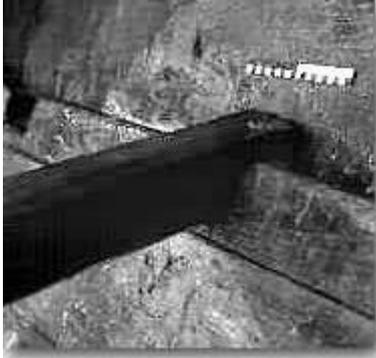
Half beam in shelf

The half beams sit in rebates which average 30mm in depth, cut in the upper faces of the shelves. One exception to this rule occurs in O8/O9, where both the stern and bow shelves respectively terminate short of the deck beam, leaving the half beam on each side of the deck beam sitting directly on the deck clamp.

In the orlop deck, small half beam shelves are used to house the outboard ends of the half beams. These were nailed to the top of the deck clamps, usually with two nails.

Each sector of the orlop deck contains two of these shelves between the deck beams and either the horizontal or vertical braces, depending on the sector in question. The half beam shelves butt up against the deck beams at one end and are either angled against the diagonal braces, or simply squared off.

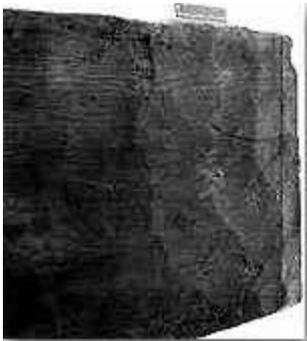
Adze marks on deck plank

The planks are flat sawn and subjectively appear to have been relatively new when the ship sank, displaying very fresh saw marks on both their upper and lower surfaces. A number of the planks have been dressed with an adze around the long edges of their upper faces, presumably to ensure an even surface with adjacent planks.

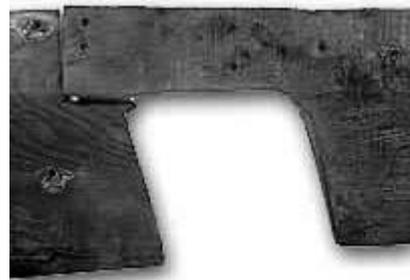
The starboard planks in each sector have a chamfered edge to allow for the upward and outward curve of the hull at this level. These planks are also shaped and chamfered to fit around the vertical and diagonal bracing that plunges through the orlop deck at its junction with the hull.

Planks shaped to fit round brace

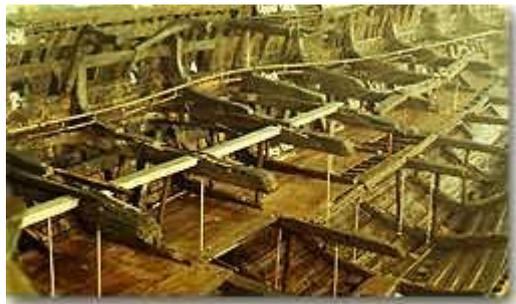
The method of fitting the planks around the braces varies. Either two planks are shaped to fit around the brace in each sector, as in O2 for example; or two planks butt against the fore and aft faces of the brace, as in O10. An exception is the outboard plank in O8, (MR82 T206) which is rebated to fit around the three exposed faces of the brace.

Orlop deck planks in-situ

The actual layout of the planks could be considered to be slightly eclectic. Essentially the basic design comprises of short planks between the knees, with longer planks between the inboard ends of the knees and the carlings.

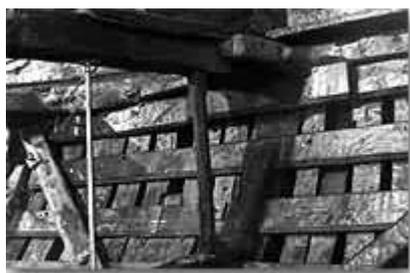
The main deck beams are rebated into a very substantial deck clamp. This deck clamp is composed of seven sections, vertically scarfed together. Unlike the other deck clamps, that of the main deck has a thicker section beneath the majority of the deck beams.

The deck beams are housed in rebates cut through the thickness of the clamps and, as on the other decks, sit proud of the rebates.

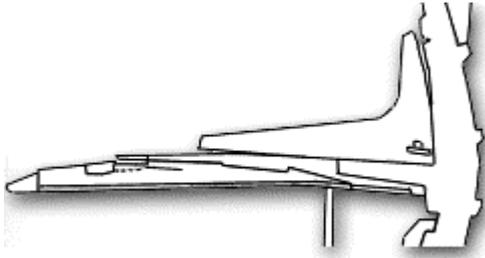
The surviving scarf starts approximately 1m from the starboard end of the beam and extends some 3m inboard. The ends of the scarf both above and below the deckbeam are secured with a pair of nails each.

M60 scarf

The main deck beams are substantial timbers between 300mm and 400mm square. From the surviving evidence it appears that, with the exception of the M60 deck beam, the beams are single pieces of timber spanning the width of the hull. M60 would have been the longest beam in the ship, measuring approximately 10.5m, and was probably originally composed of three sections of timber, jointed with locking scarfs.

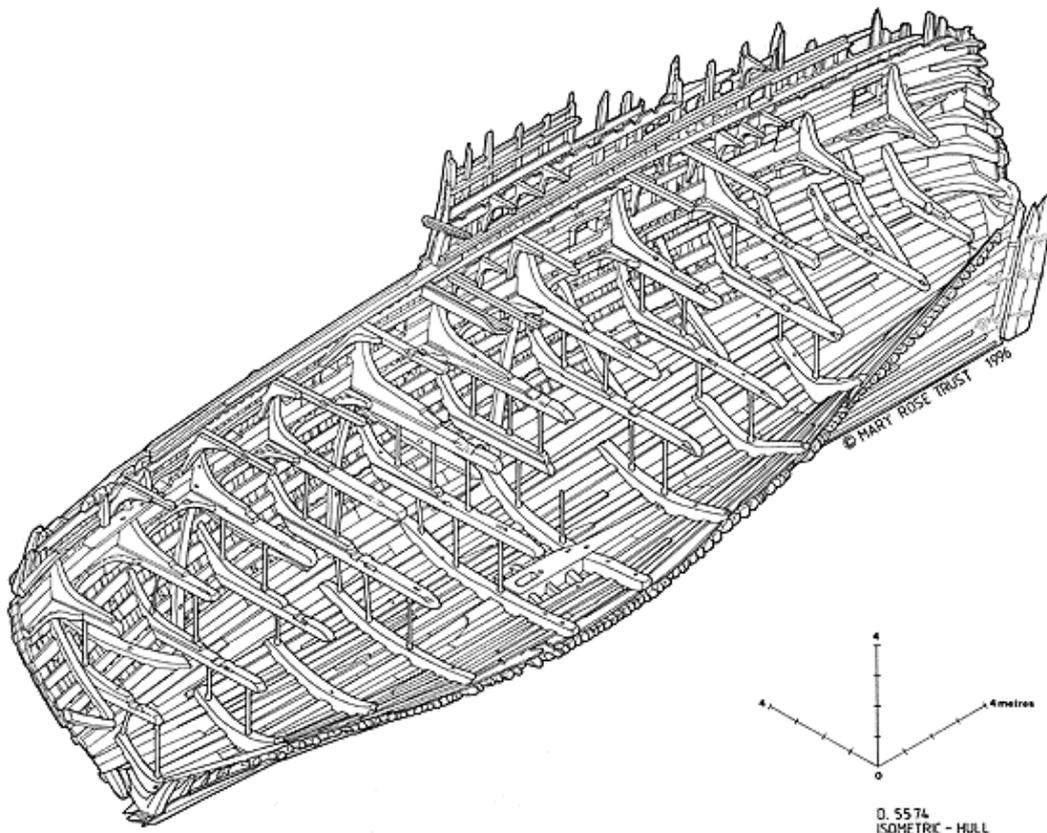
Isometric showing the deck beams

The deck beams are very firmly secured to the hull. Not only do most of them rest in thickened sections of the deck clamp, they are secured by both rising and lodging knees. Both types of knee are fastened to the deck beams with clench bolts of considerable length, usually two bolts for the rising knee and two for the lodging knees.

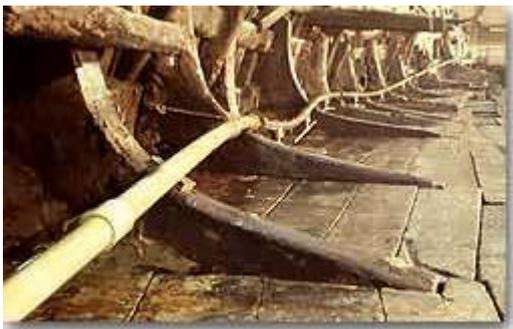
One of the major differences between the main and orlop deck rising knees is the stepping of the inboard ends of the knees to allow for a greater area of uninterrupted planking. MRK40 has a particularly pronounced step, 900mm long.

As on the orlop deck the majority (MRK10,30,40,60,70,80 and 110) have transverse lap joints on their lower faces matching those on the deck beams below.

Main deck rising knees

The main deck rising knees share most of the features of those on the orlop deck. They are made from a single piece of grown oak, are bolted to the deck beams below and are bolted and treenailed to the hull. Generally, two bolts are used for each purpose, but MRK60 is held to the deck beam with three bolts. The tops of MRK30 and MRK40 are additionally fastened to the stringer with a single nail.

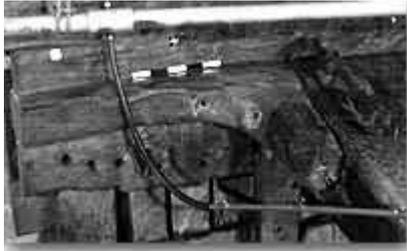
The lodging knees forward of the M60 deck beam all have shallow rebates cut in their upper surfaces to house the outboard lap joints of the main deck half beams.

Lodging knee against M10

Lodging knees are only used to support the main deck beams. These are horizontal knees with one arm situated on top of the main deck clamp and the other extending along the bow or stern face of their respective deck beams. These knees not only helped distribute the forces acting on the deck beams, they also provided a considerable degree of lateral stiffening for the beams and longitudinal strengthening for the hull. Except in M1, where the knee is incomplete, M11 where one is missing, and M12 at the stern, there are two lodging knees in each sector.

These knees are fastened to the hull with both treenails and bolts, and to the deck beams with bolts passing through each beam and the knee on either side. Two bolts are usually used for each purpose, although MR83 T1270 in M8 may have had up to four bolts holding it to the starboard side. The inboard ends of the knees are chamfered towards the fore or aft faces of the deck beams and secured with a single nail. The two lodging knees in each sector are vertically scarfed together, the lengths of the arms not necessarily being equal.

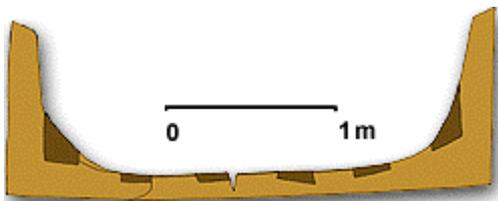
Half beam rebates on M5 lodging Knees

Aft of M60 the situation is rather more complex. The knees in M7 have no rebates, rather the half beams rest in a shelf on top of the knees. In M8 there is also a half beam shelf, but the inboard arm of stern knee has two half beam rebates as well. M9 has a half beam shelf resting on the forward knee which butts against the aft knee. M10 has no half beam shelves. M11 has a set of rebates in both the knee and in the half beam shelf. (There is only one lodging knee in H11, the other having been torn out of the ship along with the M100 deck beam).

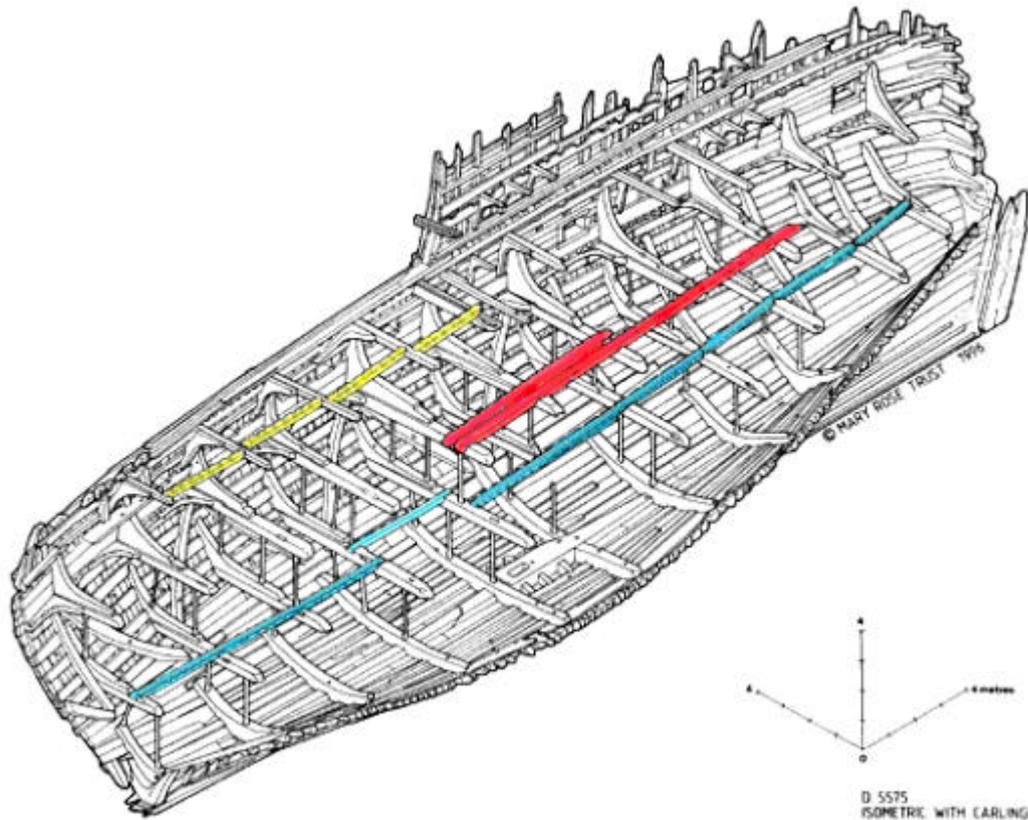
Carlings

These are the outboard carlings between M30 and M70 and the inboard carling between M50 and M70, which then continues as the sole carling to just aft of the M90 deck beam. The carlings sit in single-stepped rebates in the deck beams, similar to those on the orlop deck, passing over the deck beams.

The carling arrangement on the main deck differs from that of the orlop deck inasmuch as there was a double carling system on each side of the centreline for part of its length. There are rebates for such a system on the deck beams M30-M70, although owing to the proximity of the carlings to the erosion line, only a limited number of these timbers survive.

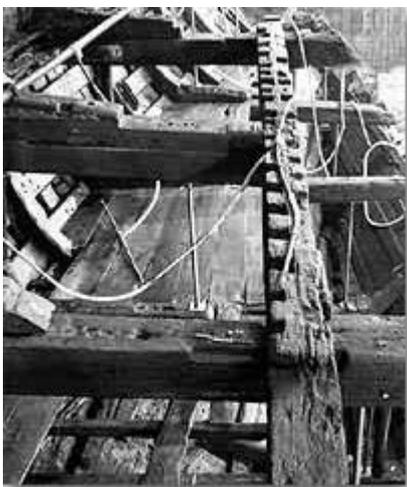
Carling between M70 and M90

The double line of carlings occupied the central section of the ship, extending forward from the M70 deck beam at least as far as M30. The outboard line of carlings terminates just aft of M70.

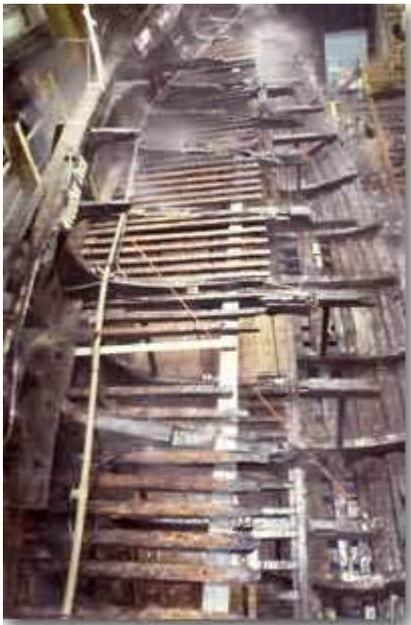
Main deck half beams

While generally similar, the main deck half beams have a number of differences from those of the orlop deck. The weight of the thicker deck planking plus that of the guns means that the half beams are more massively constructed. The distribution of the half beams is more consistent than on the orlop deck, between five and eight per sector, excepting M9, which contains eleven. In appearance, the half beams are flatter in section than the orlop deck ones.

The outboard ends of the half beams between M1 and M7 usually terminate in a lap joint that rest in the rebates in the lodging knees or half beam shelves. These lap joints are angled where the half beams rest on the inboard arms of the lodging knees. The outboard ends are angled in the horizontal plane to compensate for the longitudinal curve of the hull. In the same area, the inboard ends of the half beams are identical to those of the orlop deck.

Between M8 and M11 a change occurs in the design of many of the half beams. These feature a locking lap joint on their outboard ends, and/or a hooked joint on their inboard ends to fit angled rebates in the carlings. A. Fielding has suggested that this system would provide additional transverse stiffening in an area where the mizzen mast was probably stepped.

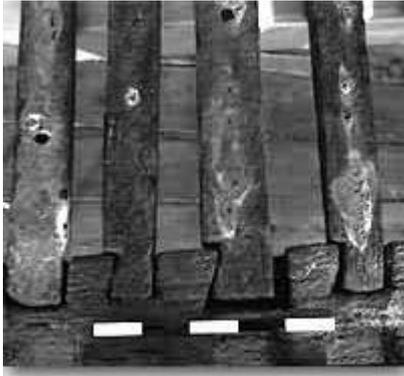
Locking lap joints in M9

The half beams were fastened to the planks with nails at least 6" (150mm) in length, usually two per half beam per plank, although this varies with the width of the planks. Around half of the beams have what appear to be disused treenail holes cut through their thickness. There is no trace of the use of treenails in the deck planking above and these holes rather suggest some sort of reuse or modification.

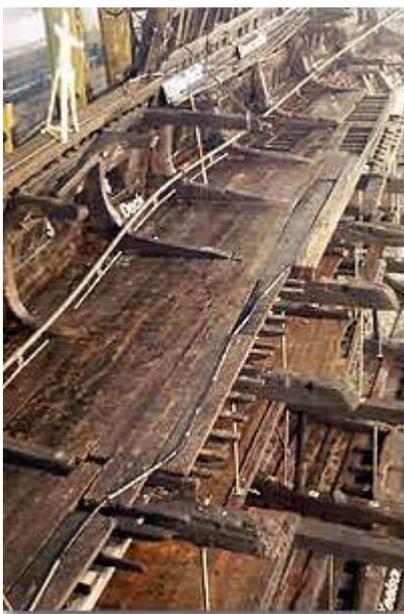
Main deck planking

The main deck planks are made solely from oak and are approximately 70mm thick on average. There are considerable variations in both the widths and lengths of the planking, with the maximum width being around 500mm and the longest plank measuring 7335mm. The planks are flat sawn, and their upper faces are generally finished with an adze. As on the orlop deck, the plank layout comprises a series of short planks between the rising knees, with longer planks between the inboard ends of the knees and the carlings. Because the knees have a step in their upper faces, the area of uninterrupted planking is greater on the main deck than on the orlop deck.

The method of compensating for the curve of the hull is similar to that employed on the orlop deck. The outboard edges of the planks adjacent to the hull have little in the way of a chamfer, the hull rising almost vertically at this point.

One of the features noted during the underwater excavation was a ridge on the inner edge of the inboard deck planks. This feature is recorded in the 1980 Trench 7 and 8 Report (p.15). Apparently between 60 and 160mm wide and 40mm high, and extending from at least M3 to M8. This feature would have acted as a coaming, preventing water from penetrating down to the deck and hold below.

The main deck planks are secured to the half beams with iron nails (see the section on half beams). These nails are set in chisel-cut countersinks of varying size and depth and these countersinks may be plugged with pitch, although this seems to be an accidental by-product of caulking the seams.

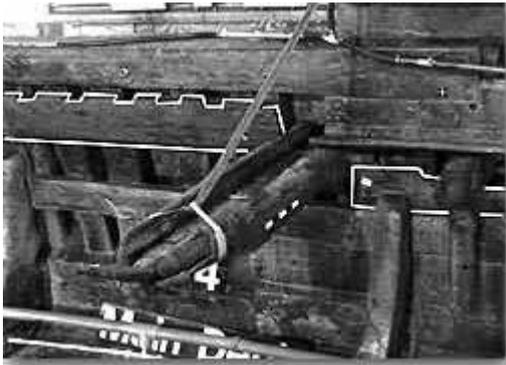
The upper deck clamps are lighter in construction than those of the orlop and main decks. On average they are 320mm high but only c.95mm thick at their widest points and c.75mm where the beams are rebated into them. The rebates are shallower than the height of the beams, which stand proud of them. The surviving forward section between U2 and U6 consists of two pieces vertically scarfed together.

Upper deck clamp (outlined in white) – showing the discontinuity between the forward and aft sections

It has both shallow half beam rebates and deeper rebates for the deck beams cut into its upper face. This section of the deck clamp terminates in a butt before reaching the daille.

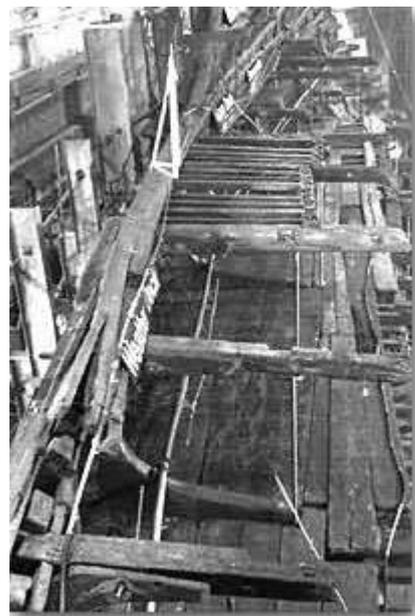
Upper Deck beams

The design and layout of the upper deck beams vary with their location. The beams forward of the aftercastle are similar in form and function to those of the orlop and main decks: they are regularly spaced and support carlings to house the half beam ends.

There are, however, significant differences between these beams and those of the decks below. In these beams the carling rebates have a double step, allowing the tops of the carlings to sit flush with the tops of the deck beams, and are therefore deeper and longer than those on the orlop and main deck beams. Because of this arrangement the rebates on each beam are staggered to avoid creating a weak spot.

The carling rebates are much closer to the starboard side than on the other decks and we assume that there was a second set of carlings each side of the centreline of the ship (and therefore a second set of carling rebates in the beams).

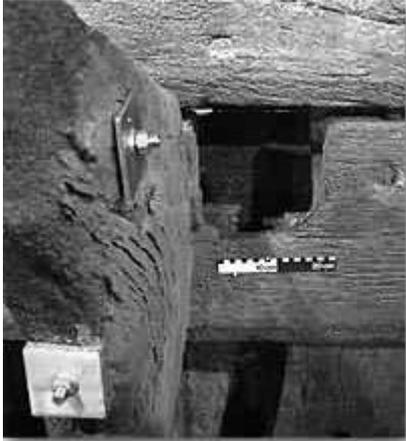
Rebates in the deck clamp house the outboard ends of the beams and they are secured to the hanging knees with a single clench bolt passing through their width. A single large nail in the inboard end of each knee helps fasten them securely to the beams.

Deck beam rebate in U3 - the modern bolts in the knee show the position of the Tudor ones

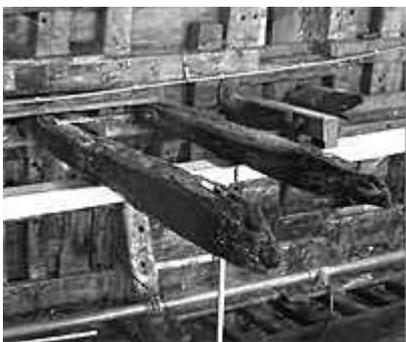
Upper deck beams in U9/10

The central daille marks a discontinuity in the upper deck. Not only is the deck lower, but the support structures for the deck planking is different from that in the forward part of the ship. There are no half beams in this area of the ship, only closely spaced (c. 1m apart) deck beams, and these in turn have no carling rebates on their surviving lengths. There is a cluster of four deck beams set closely together on the border of U9/10, possibly to help take the weight of the gun in M10, and/or to help brace the mizzen mast. It is possible that there was a similar arrangement of beneath the front of the aftercastle, with three closely spaced beams.

The middle beam is recorded as having protruded through what appears to be a port in the Barber Surgeon's cabin. Unfortunately this beam does not appear to have been recovered.

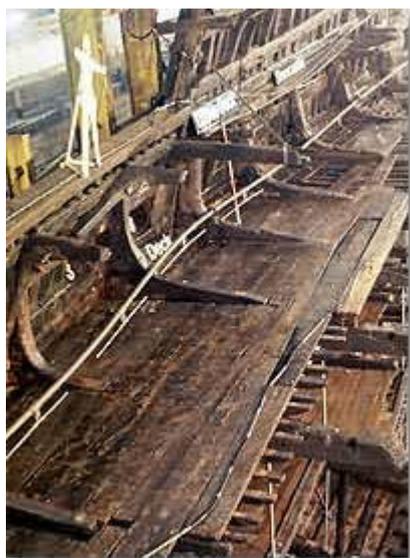
Upper deck knees

The upper deck beams are attached to the hull with hanging knees, leaving the upper deck free of obstructions. The knees are bolted and treenailed to the side of the ship and fastened to the deck beams with a single countersunk bolt through the main body of the knee. The inboard ends of the knees are fastened to the beams with a single large countersunk nail. The knees in the part of the ship forward of the daille are all fastened to the bow side of the deck beams, while those aft of the daille can be attached to either the bow or stern faces. The knees are L-shaped, with the lower arms having their outboard faces rebated to fit around the stringers. The inboard ends of the upper arms are chamfered towards the face of the beams they are supporting.

At least three of the knees in the stern part of the ship, MR81 T1484, MR 83 T1197 and MR83 T1198 have a ledge cut out of their upper arms to help support the beams.

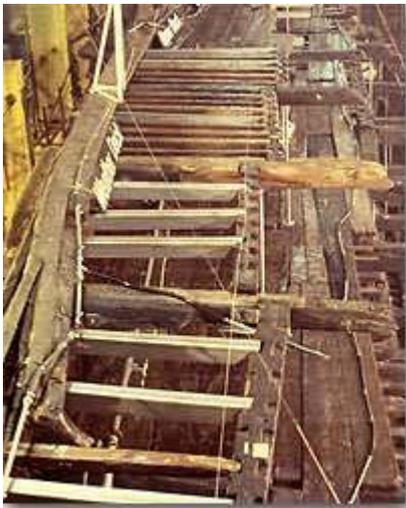
Upper deck carlings and half Beams

Carlings have only been found in the forward half of the upper deck and there is no surviving evidence for carlings aft of the central daille. These timbers have a lap joint at each end, with the exception of the stern end of the U6 carling which terminates in a butt just aft of the daille it rests on. As discussed in the section on the upper deck beams, the carlings are staggered and are closer to the side of the ship than those on the main and orlop decks. There are half beam rebates on both the port and starboard sides of the carlings, as well as surviving half beams.

It is highly probable that there was a second set of carlings each side of the centreline of the ship. These missing carlings probably formed two parallel lines with either hatches, gratings or a well between them. Since there is no carling rebate on the forward face of the U20 deck beam we assume that either the half beams extended from the starboard side to the central carlings, or the rebate was situated beyond the surviving end of the carling.

Half beams are used only in the part of the deck forward of the aftercastle, aft of that they are replaced with a system of closely spaced deck beams. There are two sets of surviving half beams, one stretches between the starboard side and the in-situ carlings, the other is housed in the inboard rebates of those carlings and would presumably have extended to a second line of carlings set closer to the centreline of the ship. The ends of the half beams are angled to fit in the carling rebates and are either similarly angled or end in a butt where they rest in the deck clamp rebates.

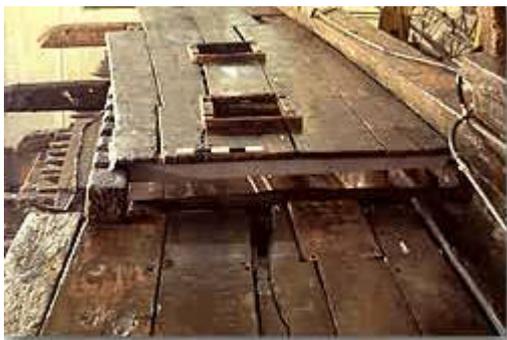
The planks in the forward half of the ship had a closely spaced pattern of nails to fasten them to the half beams, usually two or three nails per plank per half beam. The stern planks had a more widely spaced pattern of nails fastening them to the deck beams. Two nail holes per beam is the normal pattern, but clusters of two or three nails were not uncommon. The majority of the nails in both parts of the deck were set in chisel-cut countersinks. The design of the outboard planks differs between the bow and stern halves of the ship. While both sets of planks are curved along their length to fit against the hull, the stern ones have a 50mm high waterway rebated into the lining planking, whereas the forward planks are just chamfered to fit against the hull.

Upper deck planks - note the different levels fore and aft of the daille
